**DEPARTMENT OF TRANSPORTATION**

Contract #: 04-0120F4Cty: SF/ALA Rte: 80 PM: 13.2/13.9File #: 69.28**WELDING INSPECTION REPORT****Resident Engineer:**Siegenthaler, Peter**Address:** 333 Burma Road**City:** Oakland, CA 94607**Report No:** WIR-022855**Date Inspected:** 18-Apr-2011**Project Name:** SAS Superstructure**OSM Arrival Time:** 700**Prime Contractor:** American Bridge/Fluor Enterprises, a JV**OSM Departure Time:** 1900**Contractor:** Zhenhua Port Machinery Company, Ltd (ZPMC), Changxing Island **Location:** Shanghai, China**CWI Name:** An Qing Xiang**CWI Present:** Yes No**Inspected CWI report:** Yes No N/A**Rod Oven in Use:** Yes No N/A**Electrode to specification:** Yes No N/A**Weld Procedures Followed:** Yes No N/A**Qualified Welders:** Yes No N/A**Verified Joint Fit-up:** Yes No N/A**Approved Drawings:** Yes No N/A**Approved WPS:** Yes No N/A**Delayed / Cancelled:** Yes No N/A**Bridge No:** 34-0006**Component:** OBG**Summary of Items Observed:**

## WELDING INSPECTION REPORT

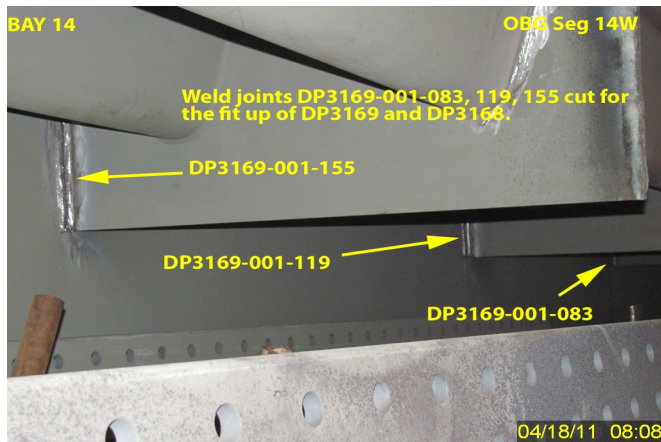
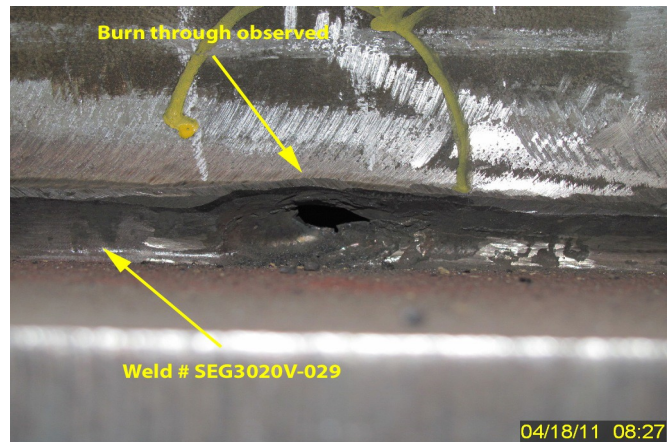
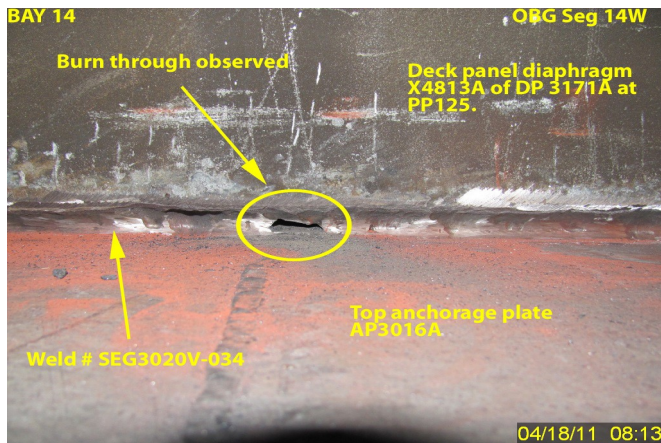
During random in process visual inspection this QA Inspector observed that weld joints DP3169-001-083, 119 and 155 at PP125.5, PP126 and PP126.5 respectively were cut by ZPMC personnel for the fit up of DP3168A to DP3169A. This cutting was done as per Welding Repair Report (WRR) B-WR20452. Attached photograph provide additional details.

During random in process inspection this QA inspector observed the burn through on the back gouged area of weld SEG3020V-034 and 029 [Joining DP diaphragm of DP3169A/DP3171A to top AP 3014A/AP3016A at PP125]. This issue has been discussed with ZPMC CWI Mr. An Qing Xiang and ZPMC agreed to do the repair as per contract document and approved repair procedure. Attached photograph provide additional details.
